CASE STUDY

Monitoring of Spring Water for Kerosene Contamination

Application Dossier: No. XV

MS1200 Oil in Water Monitor

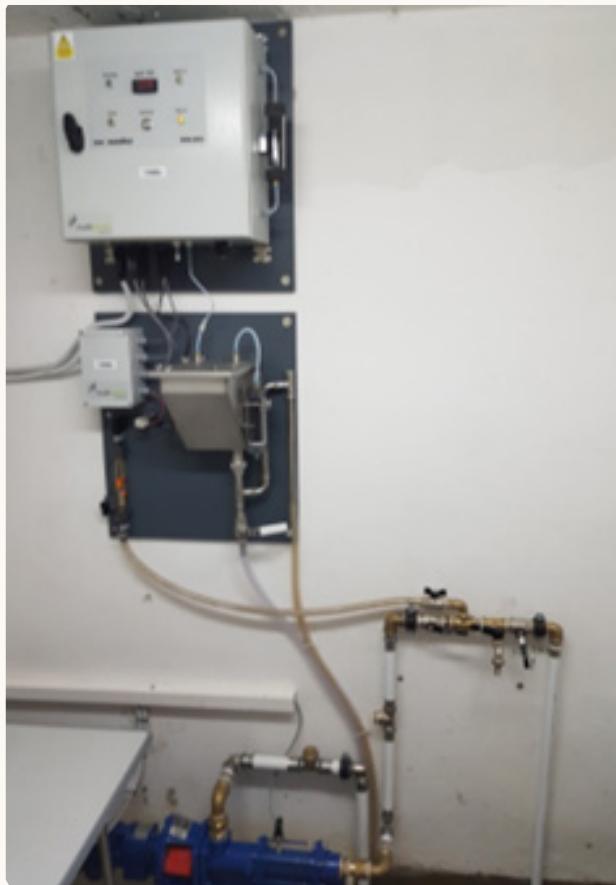
A picture of the unit installed in the outbuilding.

Multisensor was contacted to address the problem and after some consultations the MS1200 Oil in Water Monitor was installed at one of the two critical points.

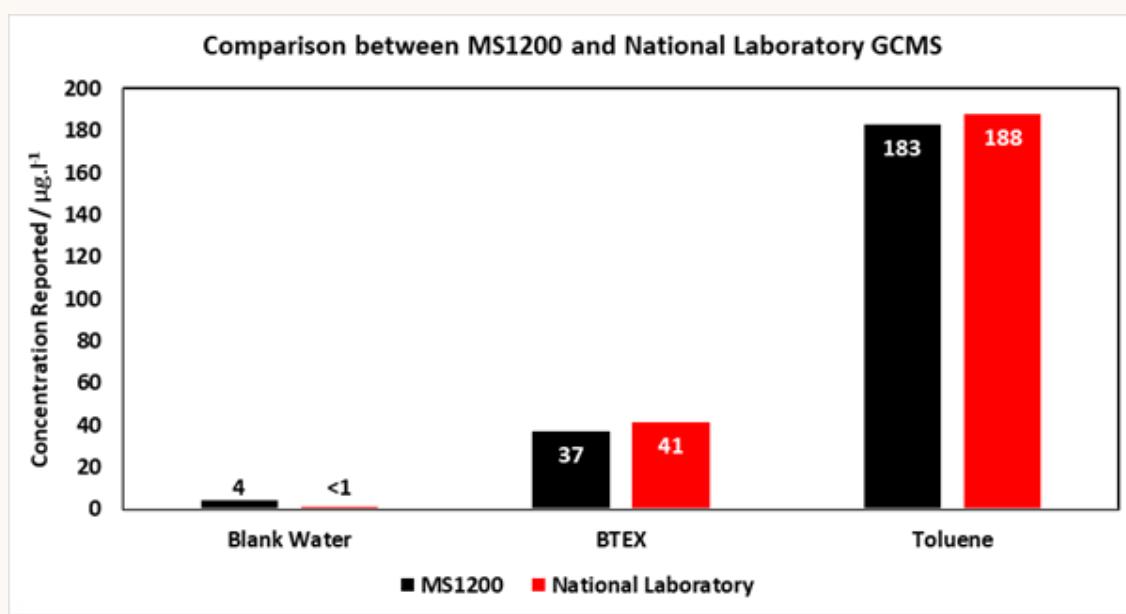
Comparison between MS1200 and laboratory for BTEX and Toluene

The instrument was calibrated and validated for toluene using Multisensor's standard method.

In March 2020, the system was also tested by the National Laboratory of Health, Environment and Food Slovenia via a comparison between a GC-MS and the MS1200 online measurements.

Measurements were conducted with a 20-minute sampling interval at an airflow rate of approximately 84 ml.min⁻¹. Measurements were conducted on a GCMS instrument (GC - Agilent 6890N, MS - Agilent 5975). Separation was performed on a capillary column (Agilent J&W DB - 624 UI capillary column; 121-1324; 20m x 180 um x 1um). The SIM technique was used for the GCMS detection.

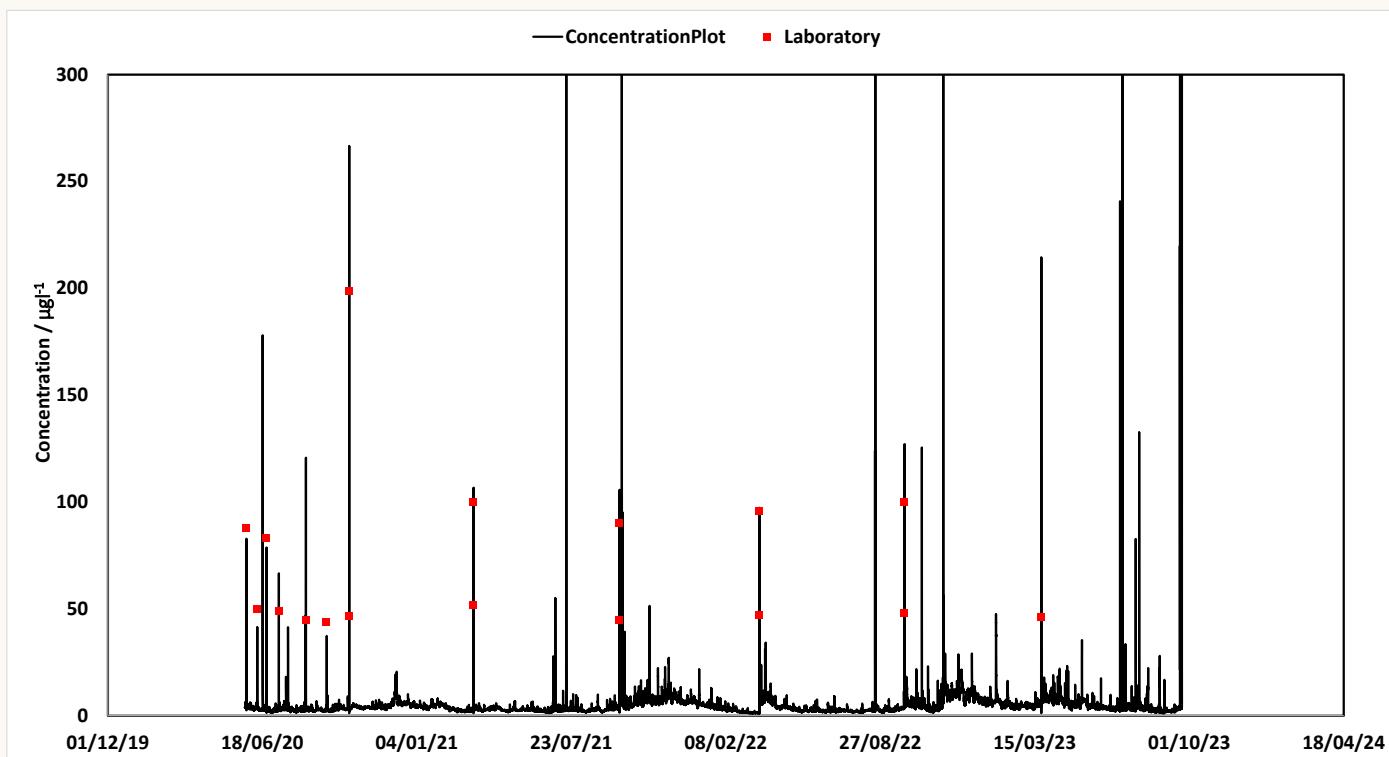
More than 3 years of data from the MS1200 installed at the intake and comparisons with laboratory.

Between 2020 and 2023 a lot of data was collected over a period of 3 years, validation checks were performed at regular intervals, always comparing results from the laboratory with standard methods and results coming from the analyser.

These results over such a long timeframe provide a good insight into the level of accuracy, repeatability and long-term stability to expect from the MS1200 analyser.

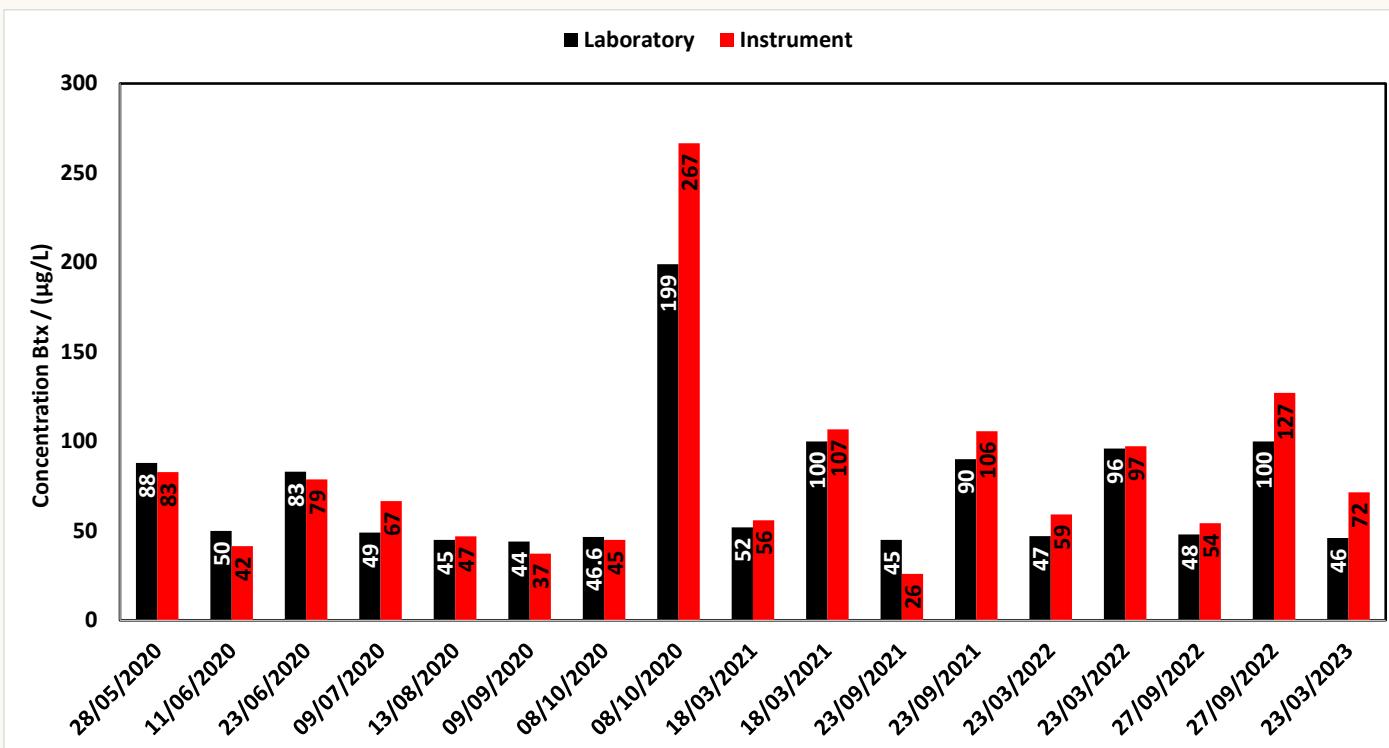
Comparisons between Laboratory and Online Instrument over a 3+ year period.
