## Spill Detection System at Engine Manufacturing Plant

Application Dossier: No. VII

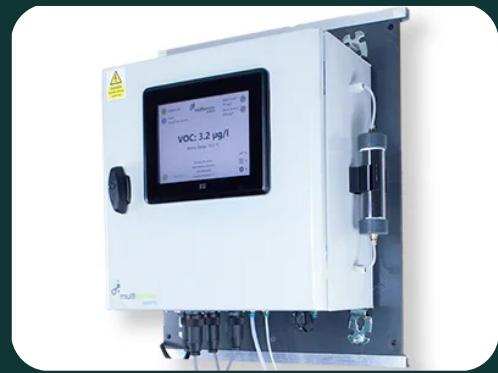
## MS1200 Oil in Water Monitor

MS1000, upgraded to MS1100, 4-20 mA output + modification that allows air to be drawn from the drain as sampling of water was not possible.

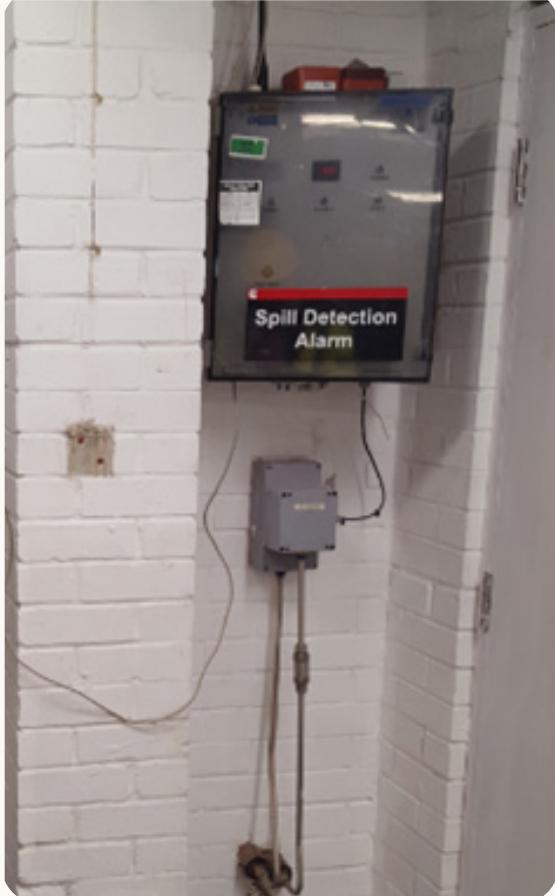
**A picture of the unit installed in the manufacturing plant.**

The system was installed after a heavy fine was issued for breaching emission limits. The system draws air into the analyser from the drain with a fan.

The instrument is used to drive an audible alarm and warning light as well as implementing an automatic fuel shut off in the event of a leak being detected.
