CASE STUDY

Monitoring of seawater for VOC pollution following accident in Vietnam

Application Dossier: No. XVIII

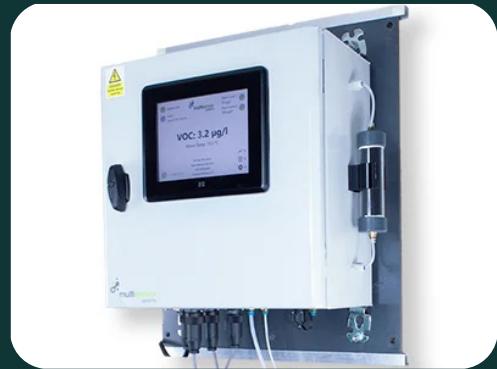
MS1200 Oil in Water Monitor

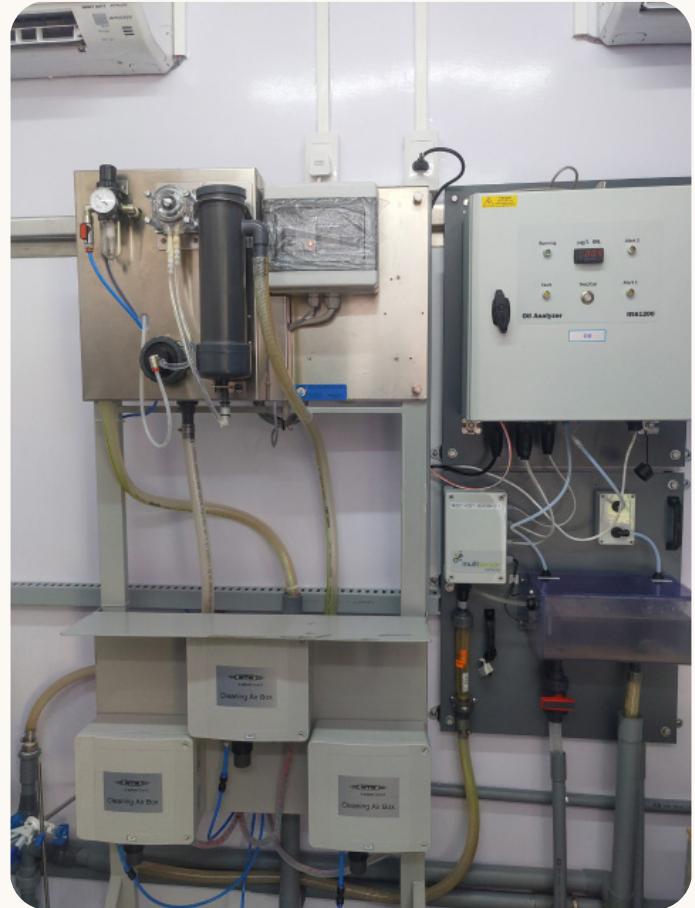
MS1200 and filtering system installed side by side

The water sample is pumped through a pipe to a shelter where the MS1200 is mounted on the wall.

The primary challenge in sea water monitoring involves the process of sampling sea water, specifically, the transportation of seawater to the monitoring station through pumping. This process is susceptible to potential damage from waves, sand, salt, and the possibility of pipe blockage due to other marine life.

To solve these issues there are two filters in the system:

- A primary filter located at the suction head, which is continuously exposed to seawater. This filter is susceptible to damage from strong waves and salt,

- necessitating frequent replacement.
- A secondary filter is situated within the station housing. This filter is positioned before the seawater reaches the analyser.

Thanks to this setup the analysers can continuously monitor the seawater and perform in the harsh marine environment.

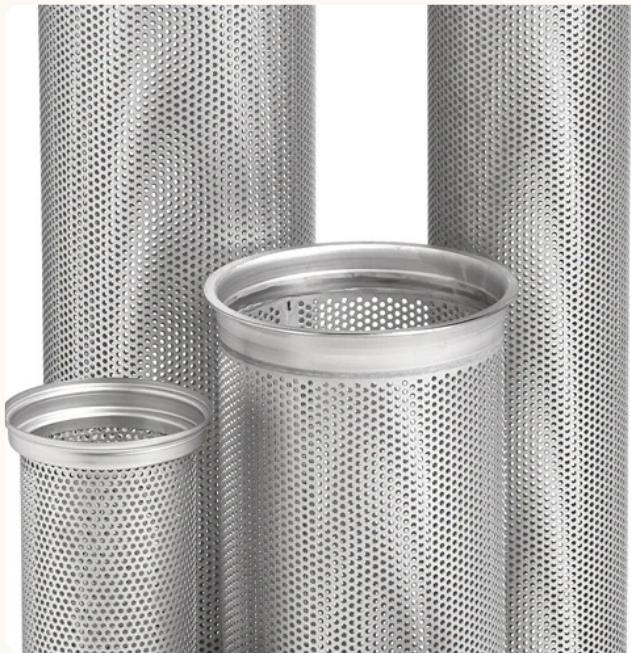
These are the kind of filters installed at the intake to avoid barnacles and other marine life colonising the piping.
